TREE INSPECTION REPORT

# Riverside Park Tree Survey

Riverside Park, Mill Lane, Exampleton EX1 2AB

| Report reference | ARB-4F1C2A-01 |

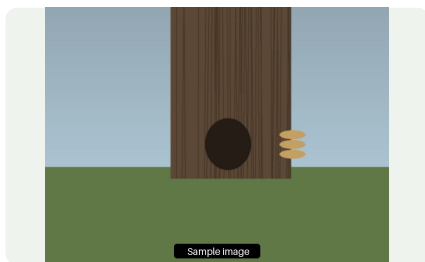
**Base** — Basal cavity and brackets, NE side (1 October 2026)

A large cavity was recorded in the basal region of the main stem on the north-east side, with severe basal decay associated with it. Fungal fruiting bodies (brackets) were present on the north-east buttress root. Moderate deadwood was recorded in the crown above the footpath.

| Defect | Severity | Notes |
|---|---|---|
| Fungal fruiting bodies (brackets) | Not graded | Bracket fungus on NE buttress root |
| Cavities | Severe | Large cavity at base, NE side |
| Basal decay | Severe | Associated with the basal cavity |

| Action | Timescale | Basis |
|---|---|---|
| Sectional dismantle / Fell to ground level | Within 1 month | Knowledge-base rule: Severe decay |

| Action | Timescale | Basis |
|---|---|---|
| Close the adjacent footpath section until works are complete | Immediately | Inspector |

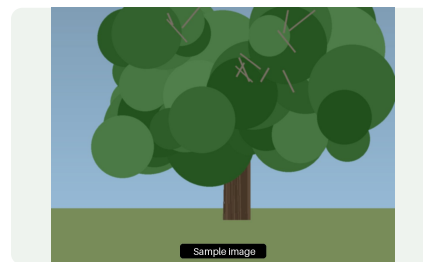
**Canopy** — Deadwood over the footpath (1 October 2026)

| Defect | Severity | Notes |
|---|---|---|
| Deadwood | Moderate | Over the footpath |

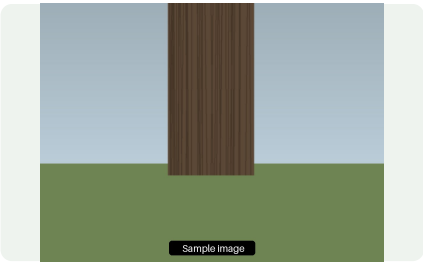
**Stem** — Co-dominant union at 3 m (1 October 2026)

Co-dominant stems were recorded with a union at approximately 3 m, where minor included bark was noted.

| Defect | Severity | Notes |
|---|---|---|
| Included bark | Minor | Co-dominant union at 3 m |
| Co-dominant stems | Not graded | Union at 3 m |

| Action | Timescale | Basis |
|---|---|---|
| Crown reduction or lateral pruning | Within 6 months | Knowledge-base rule: Proximity to target |

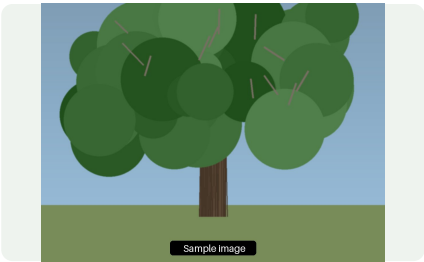
**Canopy** (1 October 2026)

| Location | 52.205121, 0.122542<br>±6 m, GPS | Proximity to target | Lateral limbs extend over parking bays 12-18 of the eastern car park |

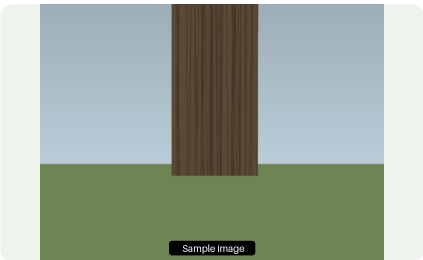
Stem — Cavity, south side (1 October 2026)

A moderate cavity was recorded on the south side of the stem at approximately 1.5 m. Minor deadwood was scattered through the crown.

| Defect | Severity | Notes |
|---|---|---|
| Cavities | Moderate | South side of stem at 1.5 m |

| Action | Timescale | Basis |
|---|---|---|
| Assess the extent of decay at the stem cavity | Within 3 months | Inspector |

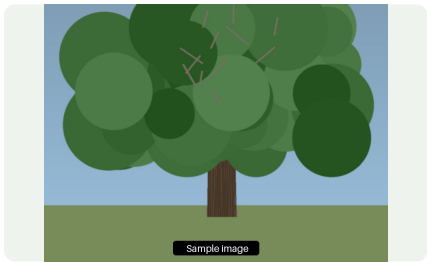
Canopy — Deadwood (1 October 2026)

Severe deadwood was recorded throughout the crown. Minor desiccation of the foliage was noted, with early browning of the leaves.

| Defect | Severity | Notes |
|---|---|---|
| Deadwood | Severe | Throughout the crown |

| Action | Timescale | Basis |
|---|---|---|
| Crown clean / removal of deadwood | Within 3 months | Knowledge-base rule: Deadwood |
